Halls, Cemeteries & Allotments Committee Meeting of Witney Town Council

Monday, 8th March, 2021 at 6.00 pm

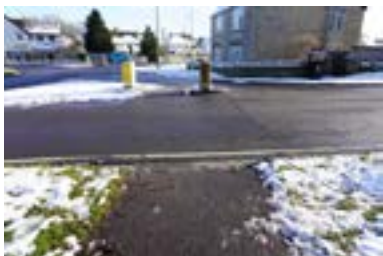
Ref	Current Findings	Recommendation	Priority
1	Getting to the site		
1.1	There is on road parking next to the cemetery, but bus stops are more the 100 m away.		
1.2	Public footways are firm and even. Dropped kerbs are provided at street crossing points but no tactile warning (blister paving). To the controlled crossing next to the kissing gate entrance blister paving has been provided.	Approach the Highways Department of the responsible authority requesting that tactile paving is provided to dropped kerbs at pedestrian crossing points.	2

Crossing point at Welch roundabout with no tactile paving	
1.3	The routes are free of hazards such as bollards and the like and any lighting columns are out of the pedestrian route.

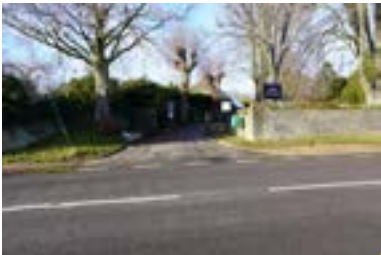
2.1.2	The vehicle entrance has signage that can be seen from the road but nothing to indicate that it leads to the car park or that it gives vehicle access to the upper area of the cemetery.	Provide information about car parking and vehicle access that can be easily viewed from the road.	2

<p>There is no visible signage advising that this leads to the car park.</p>

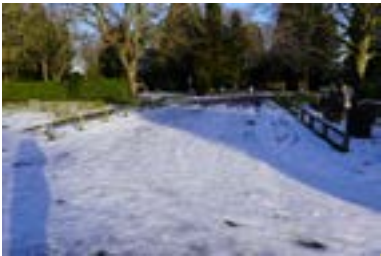
Ref	Current Findings	Recommendation	Priority
3.2	<p>The parking area is positioned between railings but also forms part of the vehicle access route around the site. Vehicle access is required not only for members of the public but also contractors and the grounds team.</p> <p>The parking area could be defined as the space between the diamond railings which is approximately 7 m wide x 17 m long. This area has to allow vehicles pass by those that are parked in it. If you take the width of the service road which is approximately 2.6 m as the minimum width required for vehicles that leaves a 4.4 m for vehicles to park in.</p> <p>An accessible parking bay is 4.8 m long with 1.2 m wide hatching to the rear, overall length 6 m. Cars will need to be parked on the diagonal to the diamond fencing or parallel to it if the 2.6 m access route is to be maintained.</p> <p>The width of an accessible parking bay is 2.4 m with 1.2 m wide hatching to one side, it is preferable if it is to both sides, the overall width is 3.6 m. The length of this area is approximately 17 m which means that four accessible bays could be provided in this area. BS8300- 1: 2018 states that religious buildings and crematoria should provide a minimum of 2 spaces or 6% whichever is the greater.</p>

<p>Provide at least two accessible parking bays.</p>	2

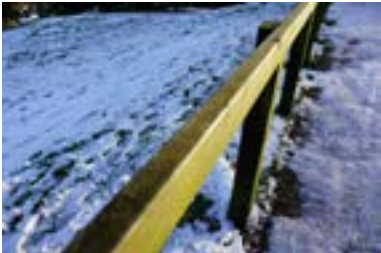
Ref	Current Findings	Recommendation	Priority
4.4	<p>Where paths have gradients that are steeper than 1:20 they should be treated as a ramp. That means handrails should be provided. The path leading from the kissing gate has a handrail to one side. The top of the handrail is between the recommended height range of 900-1000 mm. The handrail is rectangular in shape, it can still be used but the preferred shape is round or oval. The supports do not allow the user continual grip as the hand has to be removed when a support is reached. It should be possible to run a hand along the full length of the handrail and not have to move it because of a support.</p> <div>

<p>It is preferable if handrails are round or oval and that supports do not get in the way of a hand running along the rail.</p> </div>	Consider providing handrails alongside paths with gradients steeper than 1:20.	3

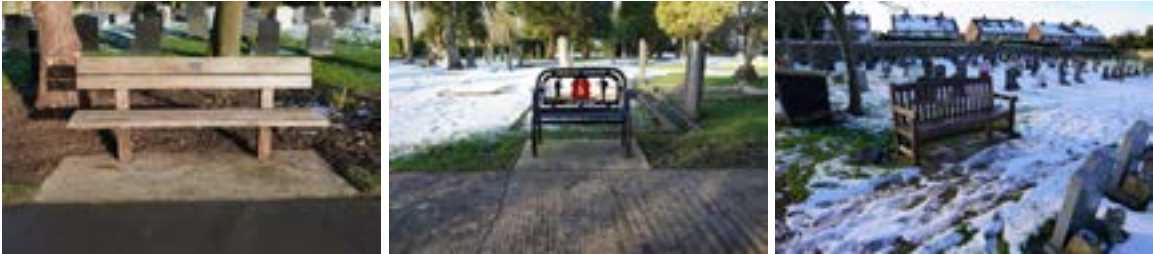
5.3	None of the seats provide an inclusive space alongside for a wheelchair user to sit. Best practice is also to provide some seating with the arm rest set in one seat width allowing a wheelchair user to side transfer. This space should have a firm and even base with level access to it that also is firm and even. It is probably unreasonable to add retrospectively but any new seating should incorporate this.	Provide seating with an inclusive space alongside for wheelchair users.	3
<div>

</div> <p>Some examples of the different seat styles but no space with firm and even ground alongside for a wheelchair user.</p>

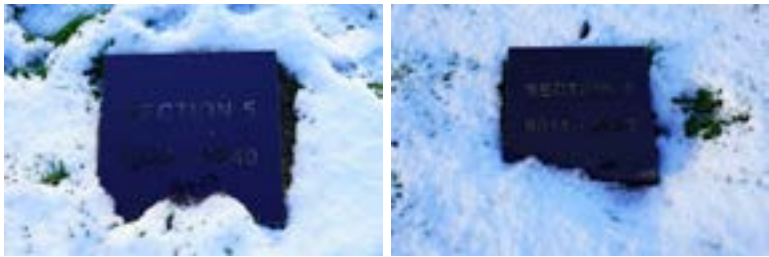
8.2 There are engraved marker stones to different burial areas, these can only be read from close up. The engraved text to these stones is not always easy to identify as the highlighting to the lettering has worn in some instances. The word 'SECTION' is in upper case, it is easier to read if the first letter is in upper case with the rest in lower case as in 'Section'.

Two examples of the section stones.

Ensure text is highlighted.

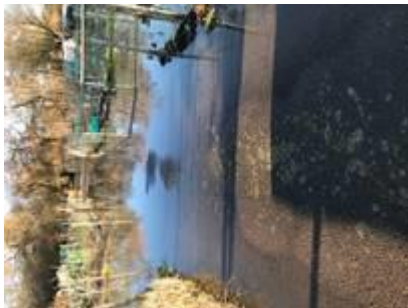
We have a serious problem at Lakeside, in that the flooding there is preventing some of the tenants from using their plots...see attached picture below, taken recently. The flooding was not limited to a particular area but did appear to affect the lowest lying plots across the site. Would it be possible to raise this with Council please, if only to get it on the agenda for discussion, with a view to discussing with us what the possible solutions might be? The cause could be that the drainage ditch adjacent to the allotments on the farmer's field side of the path running up to the Lake from Ducklington requires cleaning/dredging out, which might also be exacerbating the problem.

The picture below was taken in December, but the images in the attached zip file were taken earlier in the year in Oct; however, the problem does appear to be occurring earlier and earlier in the year. We will keep you updated with up to the minute photos of further flooding (that's if we can get our canoes onto the plots!!)
