Access Audit Tower Hill Cemetery Witney Town Council Curbridge Rd Witney OX28 5ES

25th January 2021

Executive Summary

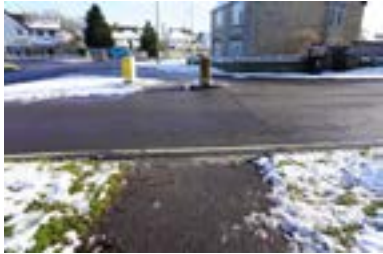
Ref	Current Findings	Recommendation	Priority
1	Getting to the site		
1.1	There is on road parking next to the cemetery, but bus stops are more the 100 m away.		
1.2	Public footways are firm and even. Dropped kerbs are provided at street crossing points but no tactile warning (blister paving). To the controlled crossing next to the kissing gate entrance blister paving has been provided.	Approach the Highways Department of the responsible authority requesting that tactile paving is provided to dropped kerbs at pedestrian crossing points.	2

Crossing point at Welch roundabout with no tactile paving	
1.3	The routes are free of hazards such as bollards and the like and any lighting columns are out of the pedestrian route.

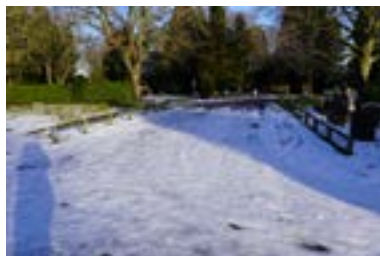
The parking area is positioned between railings but also forms part of the vehicle access route around the site. Vehicle access is required not only for members of the public but also contractors and the grounds team.

The parking area could be defined as the space between the diamond railings which is approximately 7 m wide x 17 m long. This area has to allow vehicles pass by those that are parked in it. If you take the width of the service road which is approximately 2.6 m as the minimum width required for vehicles that leaves a 4.4 m for vehicles to park in.

An accessible parking bay is 4.8 m long with 1.2 m wide hatching to the rear, overall length 6 m. Cars will need to be parked on the diagonal to the diamond fencing or parallel to it if the 2.6 m access route is to be maintained.

The width of an accessible parking bay is 2.4 m with 1.2 m wide hatching to one side, it is preferable if it is to both sides, the overall width is 3.6 m. The length of this area is approximately 17 m which means that four accessible bays could be provided in this area. BS8300- 1: 2018 states that religious buildings and crematoria should provide a minimum of 2 spaces or 6% whichever is the greater.

The parking area which measure approximately 7 m wide x 17 m long.

Provide at least two accessible parking bays.

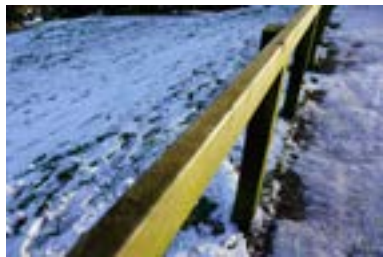
4.4 Where paths have gradients that are steeper than 1:20 they should be treated as a ramp. That means handrails should be provided. The path leading from the kissing gate has a handrail to one side. The top of the handrail is between the recommended height range of 900-1000 mm. The handrail is rectangular in shape, it can still be used but the preferred shape is round or oval. The supports do not allow the user continual grip as the hand has to be removed when a support is reached. It should be possible to run a hand along the full length of the handrail and not have to move it because of a support.

It is preferable if handrails are round or oval and that supports do not get in the way of a hand running along the rail.

Consider providing handrails alongside paths with gradients steeper than 1:20.

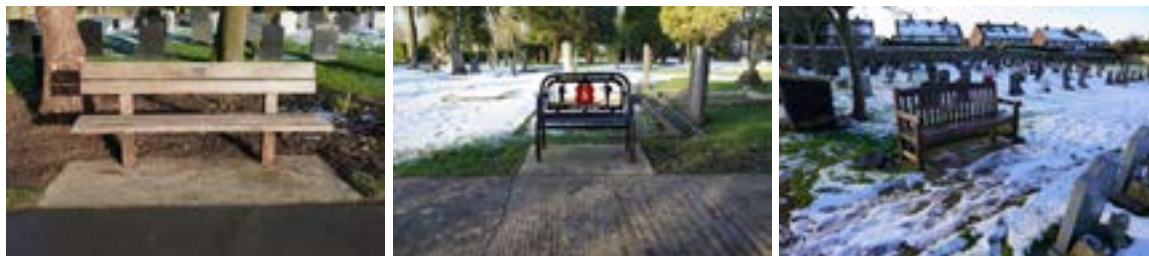
Some examples of the different seat styles but no space with firm and even ground alongside for a wheelchair user.

Provide seating with an inclusive space alongside for wheelchair users.

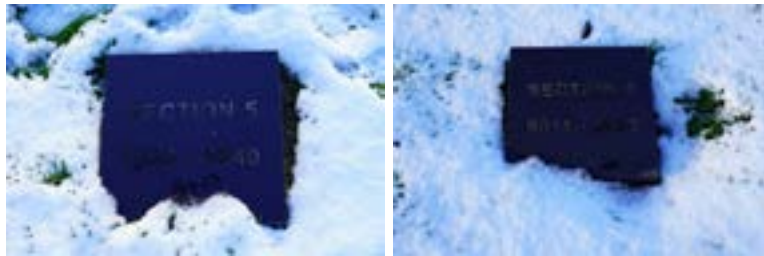
8.2 There are engraved marker stones to different burial areas, these can only be read from close up. The engraved text to these stones is not always easy to identify as the highlighting to the lettering has worn in some instances. The word 'SECTION' is in upper case, it is easier to read if the first letter is in upper case with the rest in lower case as in 'Section'.

Two examples of the section stones.

Ensure text is highlighted.
